# Performance Evaluation of Roadway Subdrain Outlets in Iowa

*Transportation Research Record: Journal of the Transportation Research Board*, No. 2462, Transportation Research Board of the National Academies, Washington, D.C., 2014, pp. 68–76.  
DOI: 10.3141/2462-09

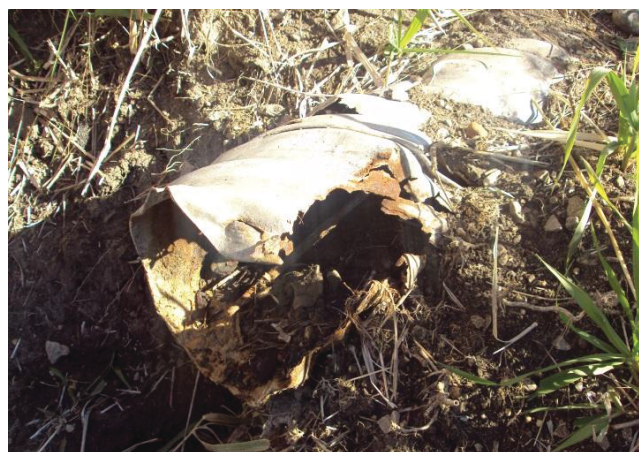
Figure 1a illustrates a damaged subsurface drainage outlet pipeline among the ones that were investigated. A damaged condition was

FIGURE 1 Damaged subsurface drainage outlet pipe in investigated Iowa roadways: (a) I-35/S/MP 127.50 and (b) distribution of damaged and undamaged drainage outlet pipes.

reported during the field survey when an outlet pipe was broken or deformed. The forensic testing revealed that less than 20% of the investigated JPCP drainage outlet pipes were damaged, while less than 10% of HMA pavement drainage outlet pipes were damaged (see Figure 1*b*).

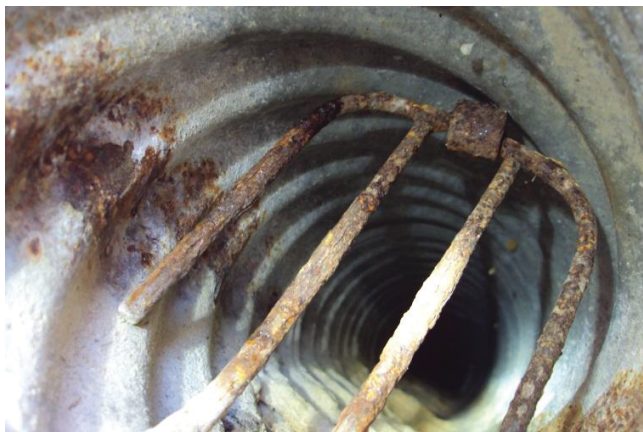
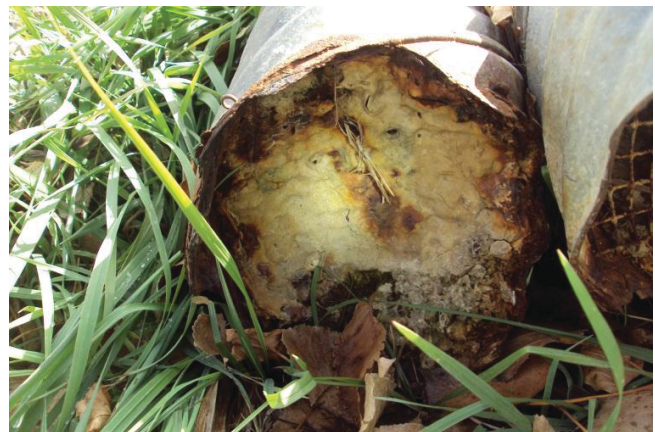
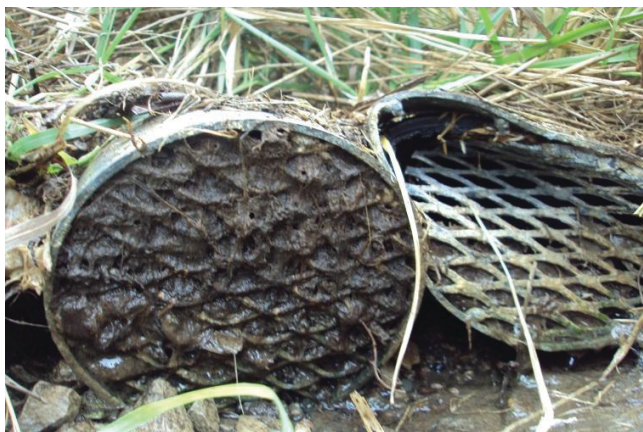
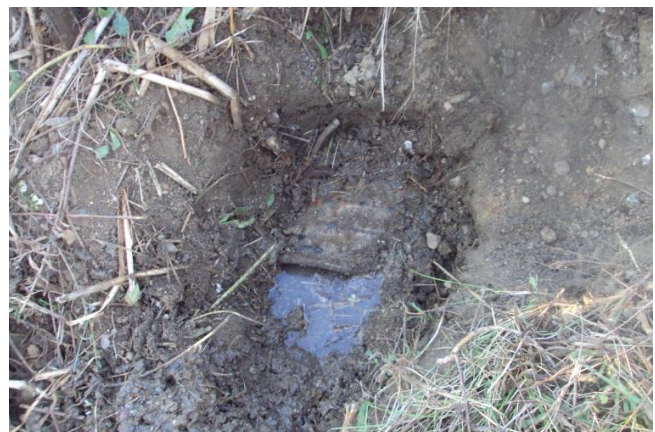
Typical drainage outlet conditions observed during field investigation include the following (see Figure 2): (a) no blockage (open), (b) tufa blockage, (c) sediment blockage, and (d) soil or aggregate blockage. No blockage was reported when the inside outlet pipe was in very clean condition. Tufa blockage was reported when there was buildup of calcium carbonate observed either inside the outlet pipe or near rodent guard screens. Tufa blockage was only observed in JPCP containing RPCC base materials. Sediment blockage was reported when dirty or debris materials were deposited inside the outlet pipe or nearby rodent guard screens. Soil blockage was reported when an end of the outlet was not exposed outside but covered by soil or aggregate.

FIGURE 2 Typical subsurface drainage outlet conditions in investigated Iowa roadways: (a) no blockage, I-35 south, Milepost 127.90; (b) tufa blockage, I-80 west, Milepost 56.72; (c) sediment blockage, IA-5 east, Milepost 86.50; and (d) soil blockage, IA-5 east, Milepost 140.35.

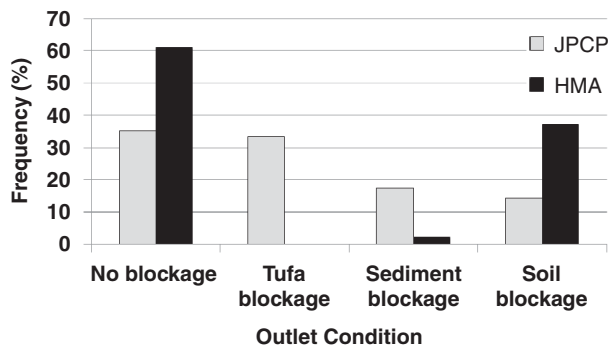
Figure 3 presents distributions of four drainage outlet condition categories in the investigated Iowa roadway sections. About 35% of the investigated outlets in JPCPs and 60% of outlets in HMA pavements were not blocked by any materials. About 35% of outlets in JPCPs were blocked by tufa, about 17% were blocked by

sediment, and about 14% were blocked by soil deposits. However, most of the blocked outlets in HMA pavements were blocked by soil deposits. Only 2% of outlets in HMA pavements were blocked by sediment.

FIGURE 3 Distribution of Iowa roadway subsurface drainage outlet condition categories.

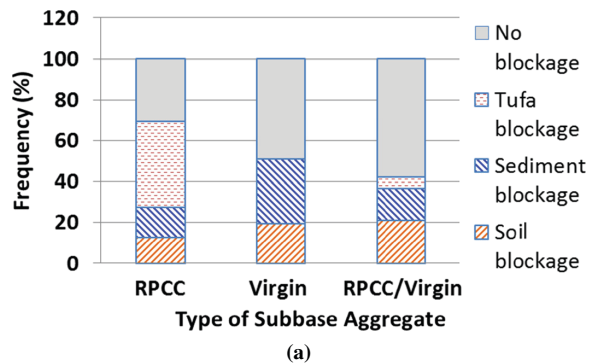
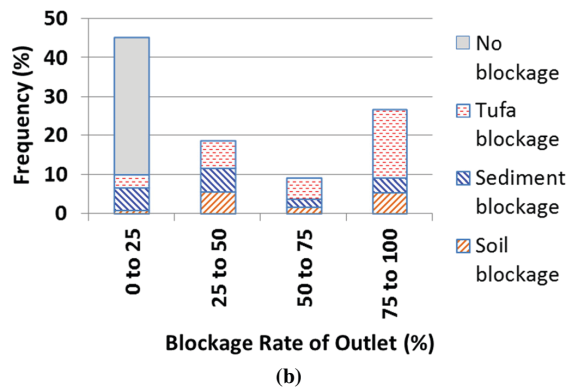
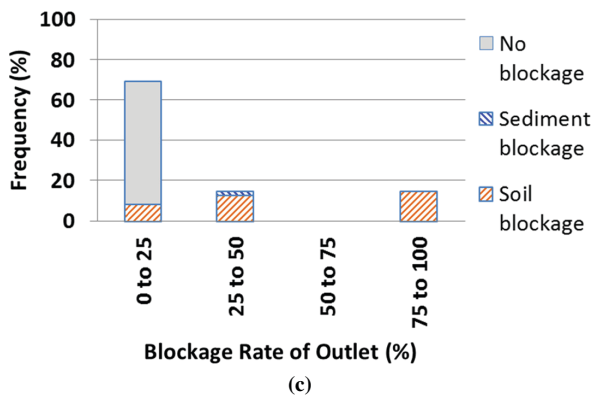
Figure 4*a* presents distributions of drainage outlet conditions with respect to JPCP base and subbase aggregate material types. Note that frequency values presented in Figure 4*a* were normalized according to each aggregate type rather than all aggregate types. As seen in this figure, tufa formation and drain outlet blockage were observed mainly in JPCP with RPCC subbase materials. Few drain outlets with tufa blockage were observed in JPCP with blended RPCC and virgin aggregate subbase materials.

Figure 4, *b* and *c*, presents blockage rates of drainage outlet conditions in JPCPs and HMA pavements, respectively. Note that frequency values in this figure were based on all outlet samples of each investigated pavement type. As seen in the figure, at higher blockage rates, JPCP drain outlets are blocked primarily by tufa rather than soil and sediment. However, irrespective of the blockage rate, the HMA pavement subdrainage outlets are blocked primarily by soil. Higher outlet blockage rates lead to slower discharge of water. However, higher blockage rates do not always stop the water from

FIGURE 4 Subsurface drainage outlet condition distributions: (a) Iowa JPCP subbase aggregate type, (b) JPCP outlet blockage type and rate, and (c) HMA outlet blockage type and rate.

flowing from inside of the outlet pipe to outside of it, unless the outlet is completely blocked (i.e., 100% blockage rate).

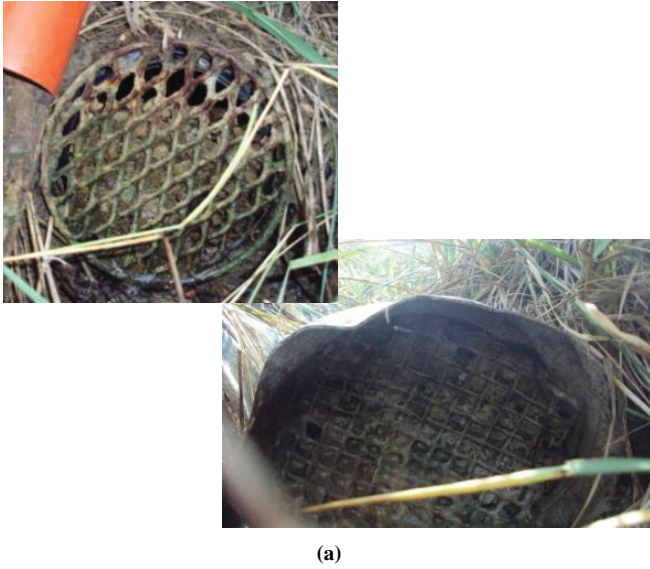
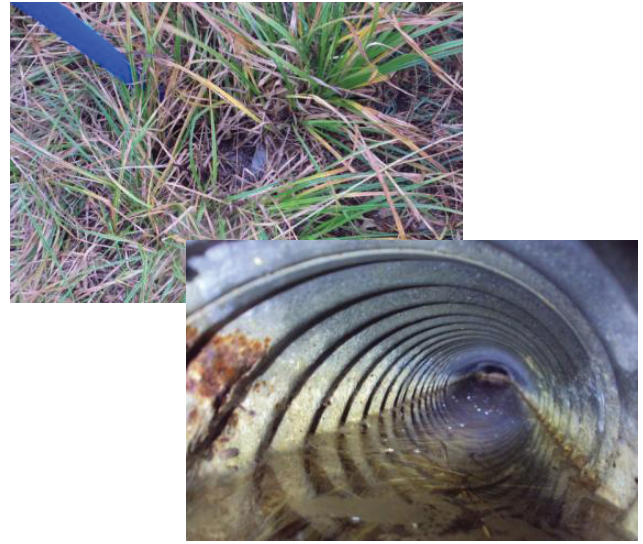
Rodent guards have been used in Iowa pavements to keep mice, rats, and other small rodents from entering subdrains. The two types of rodent guards used in Iowa are mesh screen and fork-shaped ones. Only one drainage spot was observed as having rodent evidence during the field investigation in spite of the dry fall season. In light of the significant blockage caused by tufa or sediment in many of the investigated drain outlets, further complicated by the presence of rodent guards, the question of whether or not Iowa DOT should be using rodent guards has become a moot point. The mesh screen-type rodent guards in some drainage outlets, as shown in Figure 5, is causing clogging with tufa or sediment by filtering the flow of water. Removal of the rodent guards, as shown in Figure 5, often prevents this clogging problem.

FIGURE 5 Subsurface drainage outlet conditions: (a) with mesh screen guard, I-29 north, Milepost 64.45 (top) and I-80 west, Milepost 56.72 (bottom) and (b) without mesh screen guard, I-80 west, Milepost 103.95.

- The use of gate or mesh screen-type rodent guards has the potential to cause outlet blockage. Considering that very little rodent evidence was observed in Iowa subdrainage outlets during field investigations, it is highly recommended that these rodent guards be removed from existing outlets and not be used to cover the newly installed drainage outlets in Iowa in the future.

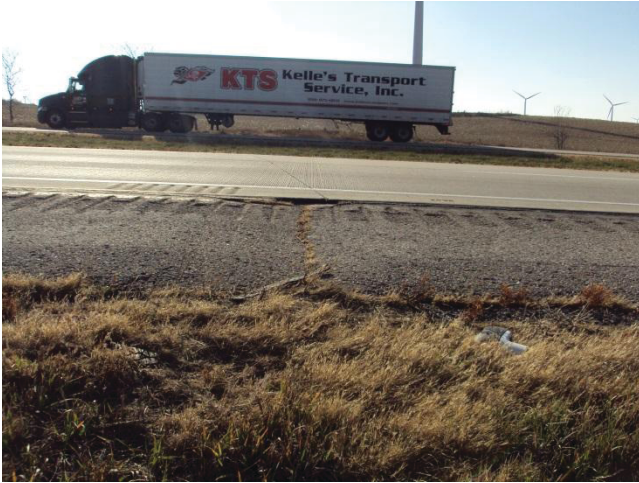
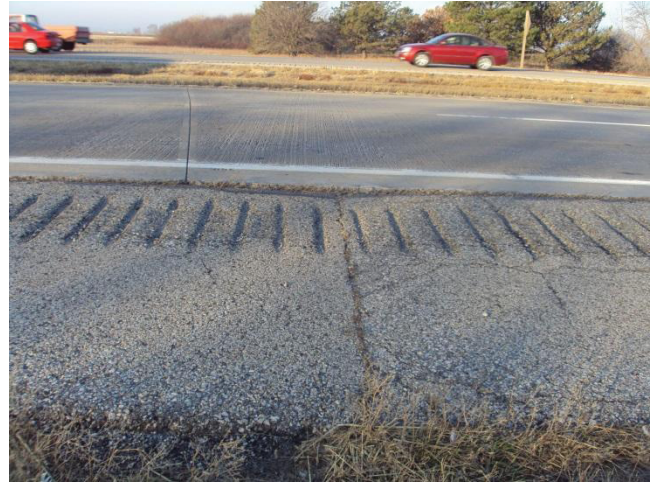
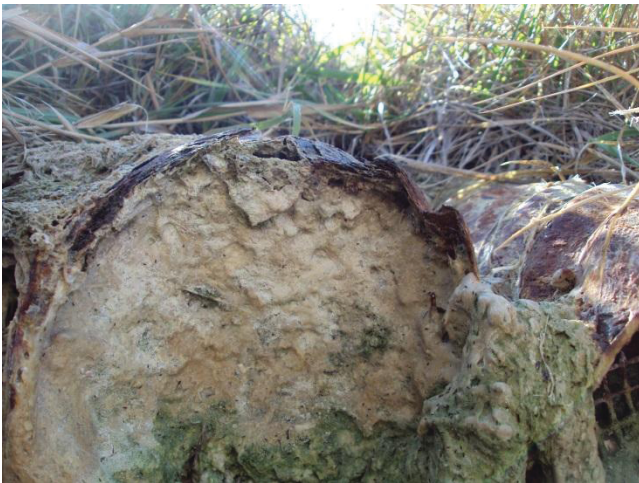
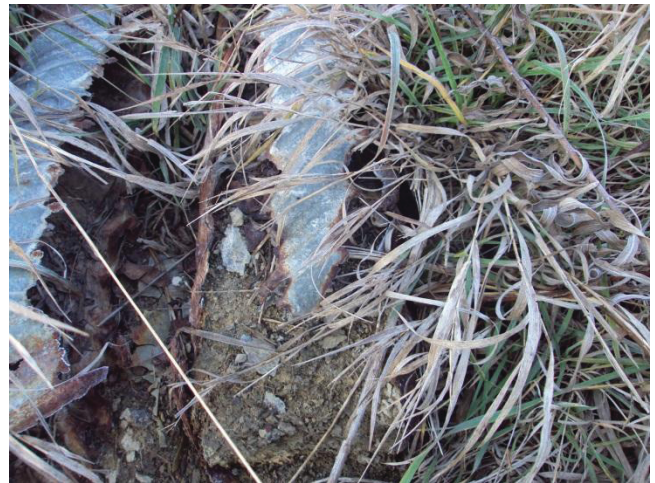
Rather than surface distresses, more shoulder distresses (shoulder drop or cracking), as shown in Figure 6, were observed near blocked or damaged drainage outlet spots. The frequency of outlet spots with observed shoulder distress under opened and blocked outlet conditions was compared. It was found that more than 10% of the blocked drainage outlet spots have shoulder distresses, while only 2% among opened drainage outlets have shoulder distresses.

FIGURE 6 Observations near Iowa JPCP blocked drainage outlet, at I-80 west, Milepost 48.30 (left) and at I-29 north, Milepost 70.84 (right): (a and b) shoulder dropping and cracking, (c) blocked outlets, and (d) blocked outlets and damaged outlets.

- It is expected that the use of a drain outlet protection mechanism, such as a splash pad mechanism used in nearby states, will be highly helpful in protecting and improving the performance of Iowa subdrains.
